Manhole Inspection Summary

Manhole # S41SS_009MH

Location Address: **2551 KIRK AVE**

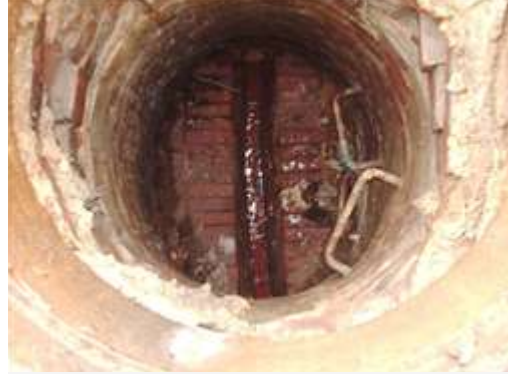
Top View

Evidence of surcharge - Bench debris.

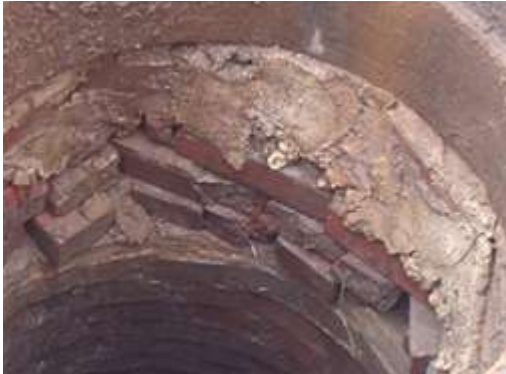
Defect

Frame leaks. Frame offset. Corbel deterioration, loose brick and infiltration - other side.

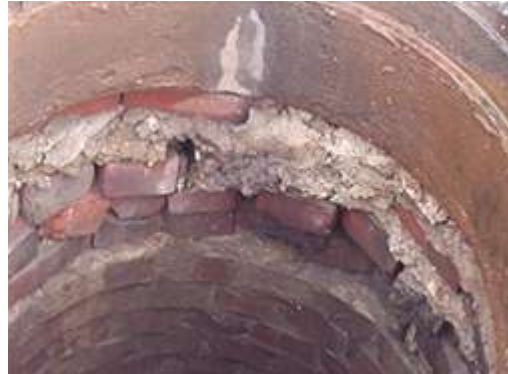
Defect

Frame leaks. Corbel deterioration, loose brick and infiltration.

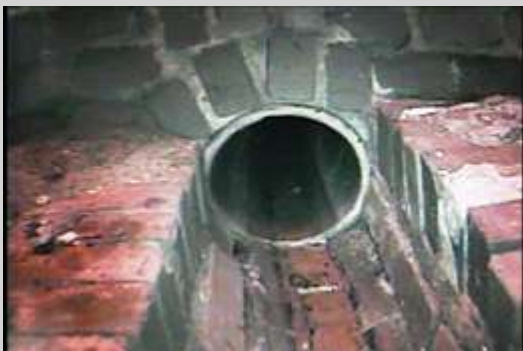
8 in. Circular Gravity Sewer Pipe In @ 6 O'Clock

Channel deterioration.

Infiltration: **Evidence** Pipe Seal Cond: **Unknown**
